Acoustical Imaging Cameras for the Inspection and Condition Assessment of Hydraulic Structures

by James A. Evans

PURPOSE: This Coastal and Hydraulics Engineering Technical Note (CHETN) describes the initial results of an investigation to determine the feasibility of using acoustical imaging for underwater inspection of structures.

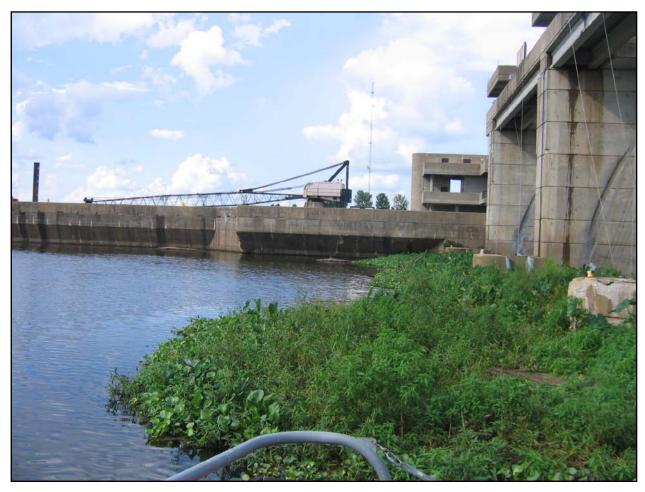
Figure 11. Overton Lock and Dam down side.

Overton Lock and Dam, near Alexandria, Louisiana. The acoustical imaging system was used 17 August 2006 to determine the amount of movement that had occurred in a section of Overton Lock and Dam on the Red River near Alexandria, Louisiana. It was believed that a portion of the dam may have moved relative to another portion.
